Exercise Desert Rock V - Marine Corps
Annex ABLE - Demonstration of Effects
of Atomic Explosion on Equipment and Clothing
DOCUMENT IDENTIFICATION Photographic Supplement

2D MARINE CORPS PROVISIONAL
ATOMIC EXERCISE BRIGADE
CAMP DESERT ROCK
NEVADA
18 APRIL 1953

Annex ABLE to Report of Exercise Desert Rock V - Marine Corps

DEMONSTRATION OF EFFECTS OF ATOMIC EXPLOSION
ON EQUIPMENT AND CLOTHING

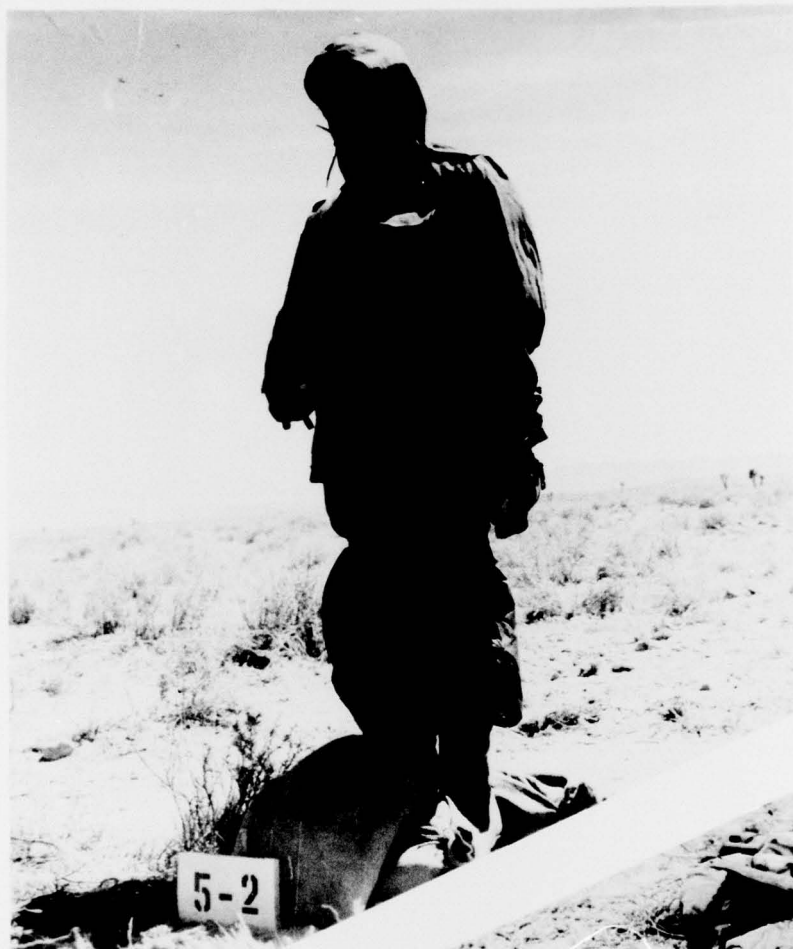
CHARRED BEYOND RECOGNITION
